EXTERIOR ENVELOPE CONDITIONS ASSESSMENT

Union School Building

DUNSTABLE, MASSACHUSETTS

DECEMBER 2021

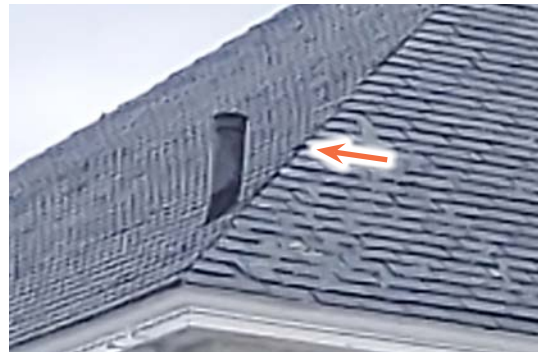
The Union School is clad in grey slate shingles, with mitered hips [Image 1.01] and open valleys [Image 1.02]. No reports of interior leaking suggest that the interwoven hip flashing is in good condition, as is the valley flashing. Overall, the slate appear to be in relatively good condition, with a few noticeable broken slates [Image 1.03]. Those that have lost at least 25% of their surface area should be selectively replaced to ward off future leaks.

Image 1.01: Mitered slate hips have a visible joint that should be protected by interleaved flashings.

- Selectively replace broken slate shingles.
- Repoint brick chimney and inspect copper ventilator for damage.
- Replace asphalt shingles at cornice with copper flashing.
- Remove any remaining gutter and downspout brackets.

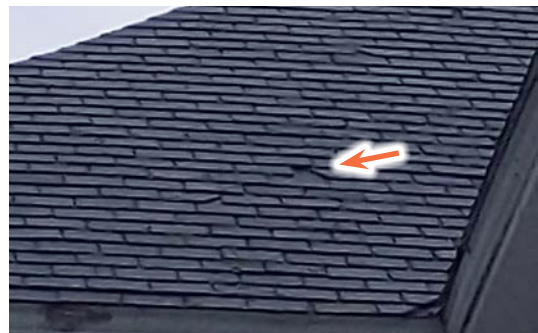
Image 1.03: Slates which are missing more than a quarter of their surface area should be replaced.

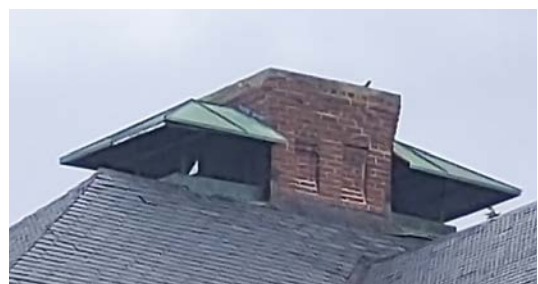
A copper-clad ventilator tower centered on the primary ridge, interrupts a large, wide brick chimney with corbeled cap [Image 1.04]. There are no reported leaks at the ventilator tower, but the chimney shows newer mortar repairs at visible cracking. The chimney really requires full repointing, during which time the associated base flashing should be replaced and the condition of the copper ventilator should be closely inspected.

Image 1.04: The wide brick chimney exhibits partial repointing, but requires a full campaign.

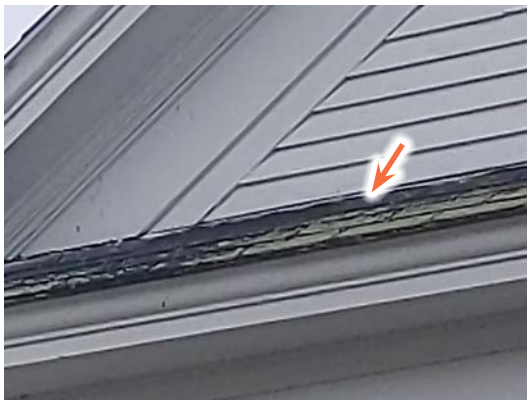
Image 1.06: Asphalt shingles at the horizontal cornice above the entry are delaminating and severely worn

A narrow coursing of the same slate roofing protects the entry pavilion. These shingles have seen more abuse than those on the high roof and require selective replacement [Image 1.05]. Asphalt shingles on the front pediment's horizontal cornice are badly deteriorated, showing delamination and organic growth [Image 1.06]. This deterioration is the most pressing, as the failed asphalt shingles will start to allow water to infiltrate the cornice and begin rotting the woodwork.

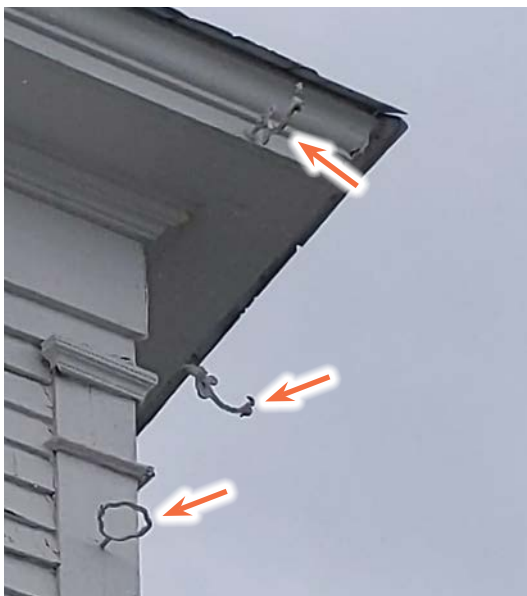
Image 1.07: Evidence of former half-round gutters and round corrugated downspouts are easily seen.

Today, there are no gutters and downspouts on the building. A row of round gutter brackets line the eaves, fastened to the fascia [Image 1.07]. Empty downspout brackets are affixed to the wood cornerboard pilaster, too. If not for the deep eaves and generous drip edge of slate, water would cascade down the face of the eave and over the exterior siding, causing far greater deterioration than seen today. The velocity of rainwater and adequate drip edge prevents this, indicating that it is not necessary to replace the missing gutters and downspouts.

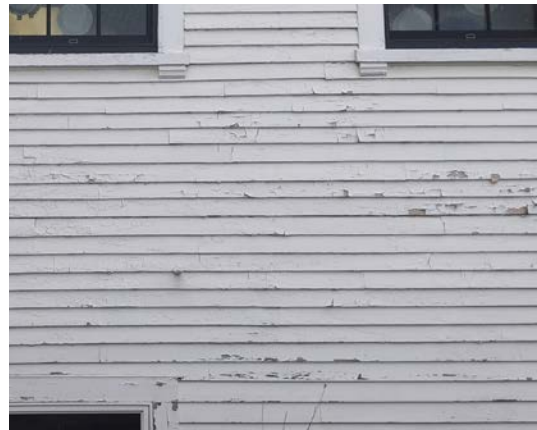
Image 2.01: The wood clapboards are well-maintained, but need a thorough repainting with historic colors.

- Conduct paint analysis to determine historic colors.
- Use safe lead-management practices to completely strip, contain, and dispose of all lead-containing paint.
- Replace missing elements and repair siding, trim and other woodwork using South America Mahogany FEQ. Refasten loose mouldings.
- Repaint all wood siding and trim throughout with an oil-based primer and high quality latex topcoat.
- Prep and paint existing stair handrails.
- Consider replacement of missing flagpole.

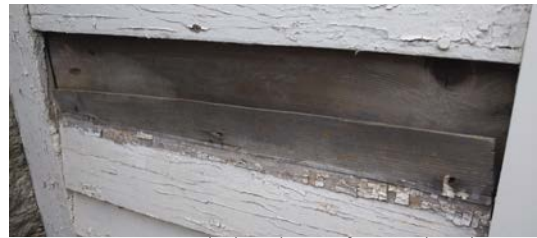
Image 2.02: Missing clapboards are infrequent but obvious, and should be replaced.

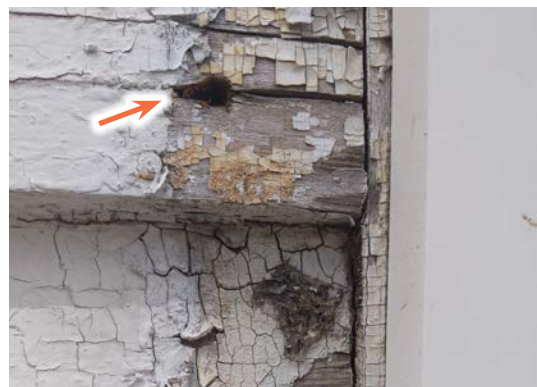
Image 2.03: Ferrous nails have a tendency to rust and split open clapboard when exposed to moisture and air.

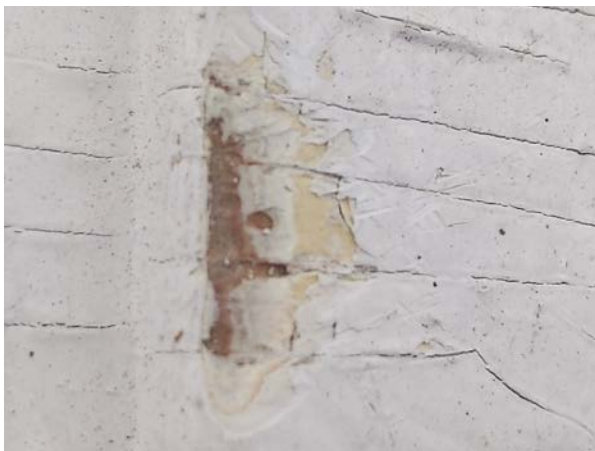
The white paint is certainly not the original color, as bright whites are not historically common for a building of this period. A damaged section of paint layers reveal buff and off-white shades [Image 2.05]. A historic paint analysis should be

Image 2.05: The many layers of lead paint should be professionally analyzed to determine historic (and appropriate) colors.

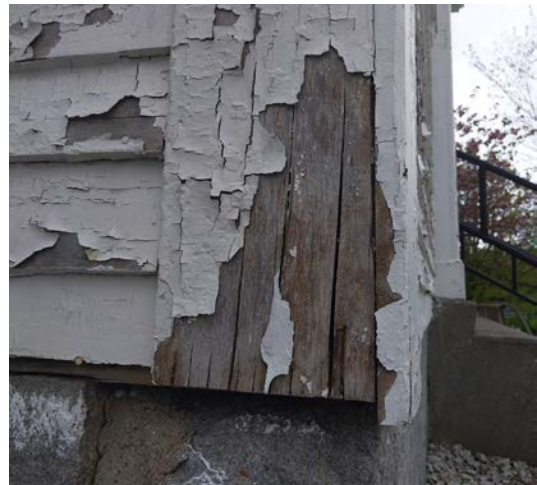
Notable instances of deteriorated wood are at the base of some cornerboard pilasters, which are checked and splitting [Image 2.10]. The worse instances would require replacement via dutchman repair, where new sections of wood are spliced into existing. Loose trim, such as that found at the rake should be refastened [Image 2.11]. In at least one location, at the base of the valley flashing, cascading water has deteriorated the wood cornice more than anywhere else, requiring more extensive repair [Image 2.12].

Image 2.10: Deteriorated cornerboards and skirts may require repair or selective replacement before repainting.

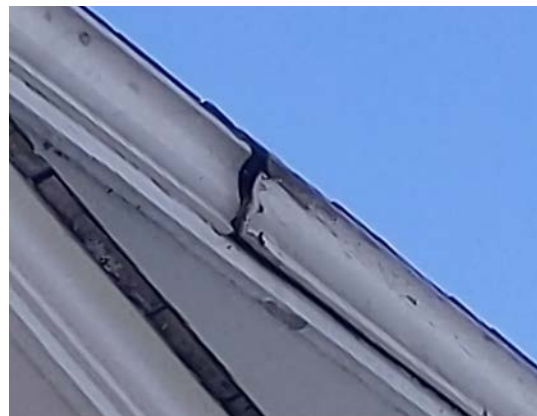
Image 2.11: Loose or missing trim should be refastened after making any repairs.

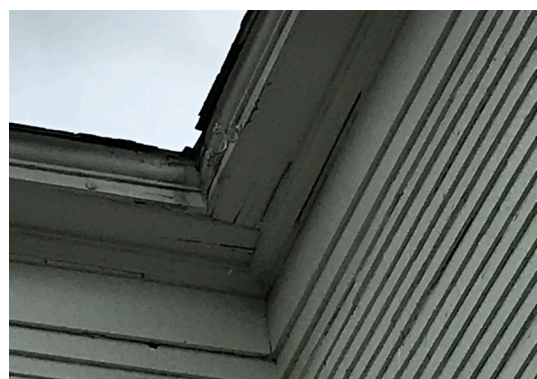
Image 2.12: An inside-corner eave exhibits additional damage from the valley flashing's lack of gutter below.

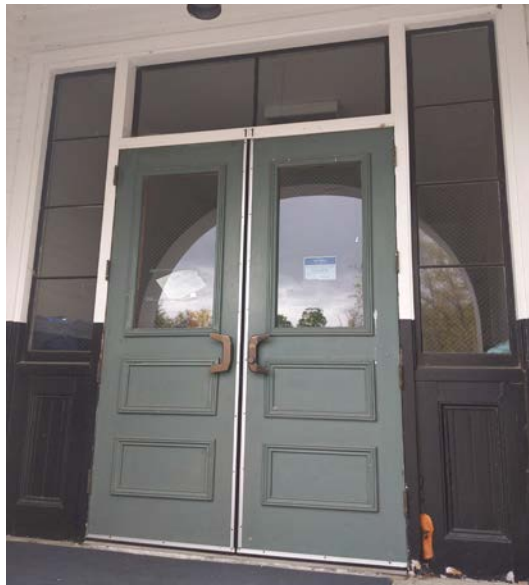
Image 3.01: Sage-green doors are protected by the alcove, but need a new coat of (appropriately colored) paint.

The front entry doors, having the protection of the deep alcove, are in very good condition [Image 3.01]. The sage-green paint has started to show its age in a few areas, likely not the original color.

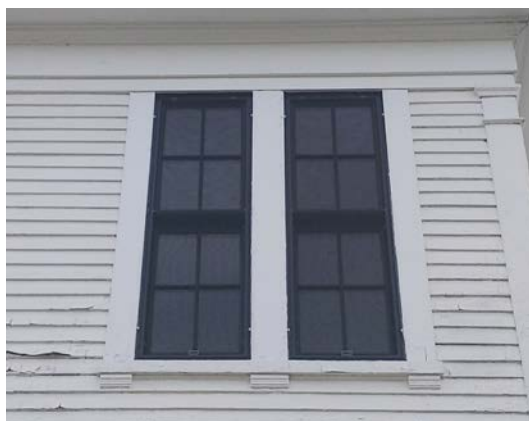
Image 3.03: Jet-black, modern aluminum clad wood windows are in excellent condition.

Tall, slender windows elsewhere on the building are black aluminum clad wood replacement windows that are new, replaced sometime in the building's recent history [Image 3.03]. The windows themselves are in excellent condition. The wood casings and sills are in fair or good condition, typically requiring the same scraping, preparation, and repainting as the wood trim elsewhere [Image 3.04]. Pitched crown mouldings at the top of window casings require more surgical repairs, as they have suffered the most deterioration from

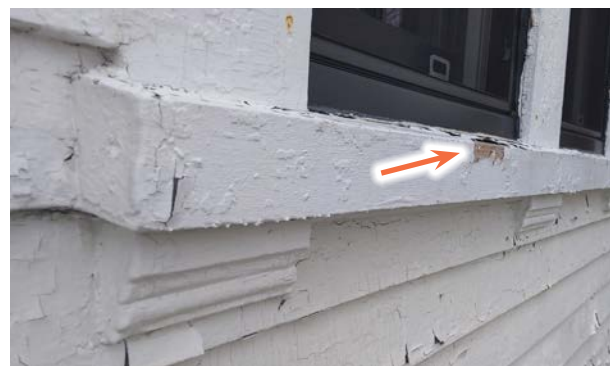
Image 3.04: Window trim details are generally well-maintained, but require thorough scraping and repainting.

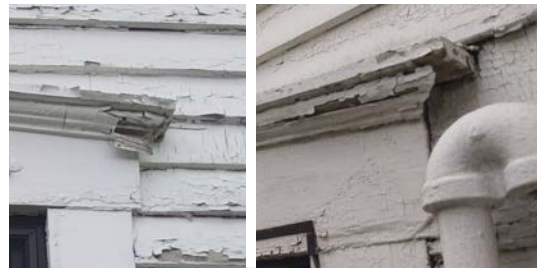
rainwater, and should be re-flashed [Image 3.05].

Image 3.05: Deteriorated window trim is typically limited to the crown mouldings.

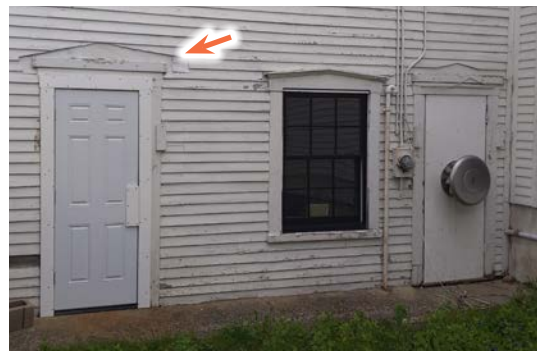
Missing casings, a pressed metal door, and a sealed door with vent turbine are a few transgressors in the otherwise uniform array of openings [Image 3.06].

Image 3.06: Missing trim and an awkward selection of doors should all be replaced.

- Restore deteriorated wood Palladian window, including trim, sash, glazing, and hardware.
- Replace metal and missing doors at rear elevation with wood paneled doors, of a design appropriate for the building era.

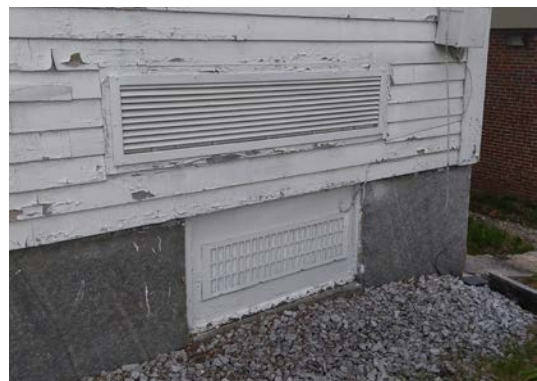
A handful of wide intake grilles on each side of the building are inserted into older cased openings for the same purpose, which are no doubt part of the fresh air system which leads to the rooftop ventilator [Image 3.07]. Some basement windows sit within the granite foundation, also aluminum clad wood [Image 3.08].

Image 3.07: Intake grilles at the building are part of the overall ventilation system, exhausting at the rooftop.

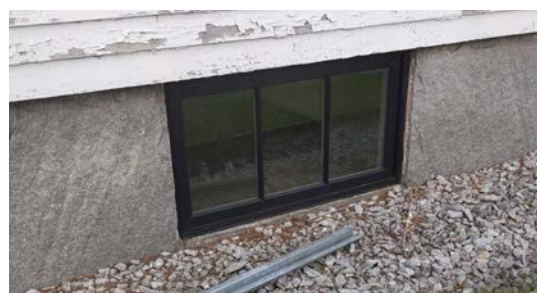
Image 3.08: Basement windows interrupt the foundation, made of the same black aluminum.

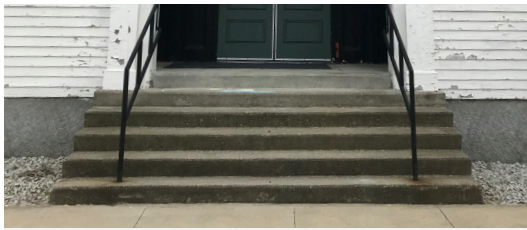
Image 4.01: The concrete steps are unmarred and intact, however dull they may appear.

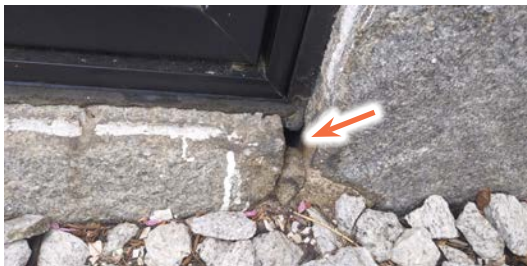
Image 4.03: Small openings in the basement window sill joints are a potential site for future leaks.

The school greets visitors with a set of wide, concrete steps which lead into the recessed entry alcove [Image 4.01]. The steps are intact and show no signs of cracking or any real damage. The building sits upon a smooth grey granite most likely from the Chelmsford quarry. The blocks of granite are long and monolithic with very few head joints, save for at outside corners and intermittent windows [Image 4.02]. Some open mortar joints at the corners of windows are a risk of water infiltration, and should be easily addressed by repointing [Image 4.03].

- Repoint granite foundation head joints.
- Repoint coarse stone retaining wall.

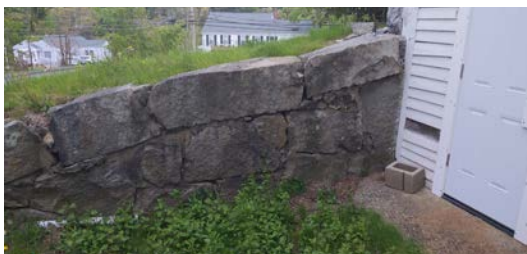
Image 4.04: A coarse stone retaining wall at the rear is in need of basic repointing.

Irregular stone retaining walls demarcate the change in grade on one side of the building, which could benefit from a brief repointing campaign to ward off future damage [Image 4.04].

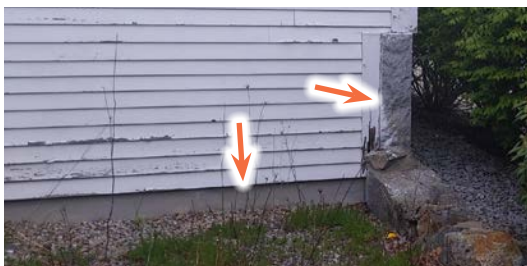
Image 4.01: A modern concrete foundation appears to have been installed with the new connector addition.

On the opposing corner, the end of the previously mentioned granite is exposed, where it comes in contact with a modern concrete foundation on the rear of the schoolhouse [Image 4.05]. This concrete foundation was likely added in conjunction with the modern connector to provide lateral support where it bridges the original building and larger complex.
