EXTERIOR ENVELOPE CONDITIONS ASSESSMENT

Union School Building

DUNSTABLE, MASSACHUSETTS

DECEMBER 2021

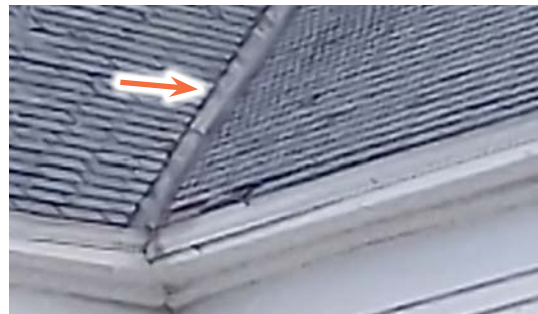
The Union School is clad in grey slate shingles, with mitered hips [Image 1.01] and open valleys [Image 1.02]. No reports of interior leaking suggest that the interwoven hip flashing is in good condition, as is the valley flashing. Overall, the slate appear to be in relatively good condition, with a few noticeable broken slates [Image 1.03]. Those that have lost at least 25% of their surface area should be selectively replaced to ward off future leaks.

Image 1.02: The open slate valleys are flashed by a strip of flashing with a pronounced 'V' to stop splashing rain.

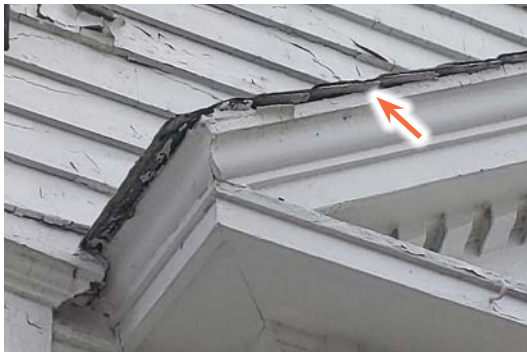
Image 1.05: A narrow band of slate shingles protecting the entry pediment peek out from over the crown moulding.

A narrow coursing of the same slate roofing protects the entry pavilion. These shingles have seen more abuse than those on the high roof and require selective replacement [Image 1.05]. Asphalt shingles on the front pediment's horizontal cornice are badly deteriorated, showing delamination and organic growth [Image 1.06]. This deterioration is the most pressing, as the failed asphalt shingles will start to allow water to infiltrate the cornice and begin rotting the woodwork.

- Selectively replace broken slate shingles.
- Repoint brick chimney and inspect copper ventilator for damage.
- Replace asphalt shingles at cornice with copper flashing.
- Remove any remaining gutter and downspout brackets.

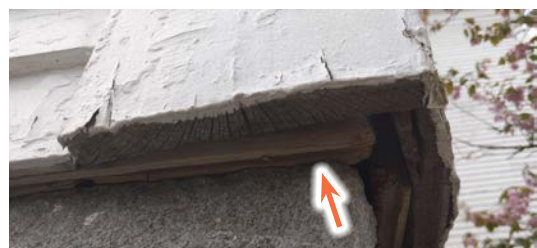
The building is uniformly clad in white wood clapboard siding. Generally, the wood is intact and without signs of endemic deterioration, although the paint is tired and starting to consistently flake [Image 2.01]. Notable examples of deterioration include missing and lifting clapboards [Image 2.02]. The ends of some clapboards, where ferrous nails have rusted and split the wood are seen intermittently, requiring selective repair [Image 2.03]. Evidence of tongue-and-groove board sheathing can be seen by inspecting the underside of some cornerboards, the condition of which is good, evidenced by the flat, even wall surface [Image 2.04].

Image 2.04: Tongue-and-groove board sheathing is visible beneath the clapboards.

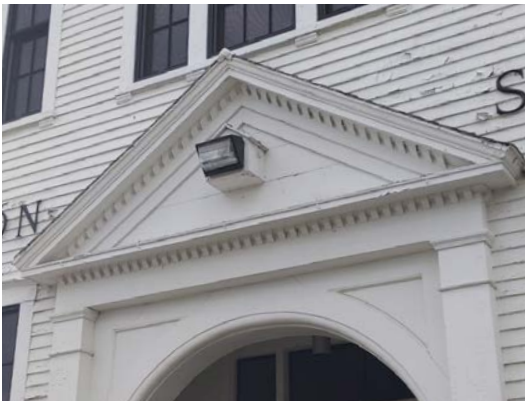
Image 2.06: A Classical Revival pediment and entablature are hallmarks to this era for places of learning.

The Union School’s Classical Revival aesthetic is communicated most clearly at its pedimented entry pavilion, with full entablature including raking cymatium and dentils [Image 2.06]. The woodwork appears to be in very good condition, in need of only preparation and repainting for the most part.

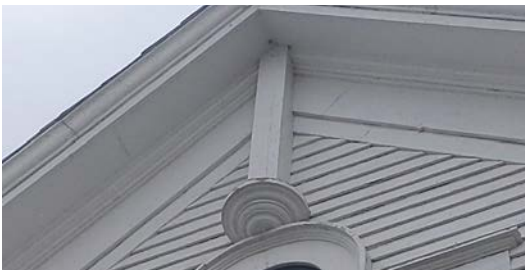
Image 2.07: A flagpole bracket and sleeve are the only evidence that one may have ever been present.

By the peak of the front facade’s gable end, a former flagpole was confirmed by the historic photo to be situated within the wood sleeve and bracket seen today [Image 2.07], both in good condition. Wood jambs at the arched entry have split where iron handrails were fastened into [Image 2.08]. The damage is likely to not advance any further, but should be monitored. Protection by the entry has afforded its interior woodwork to remain unscathed, its paint only slightly faded [Image 2.09].

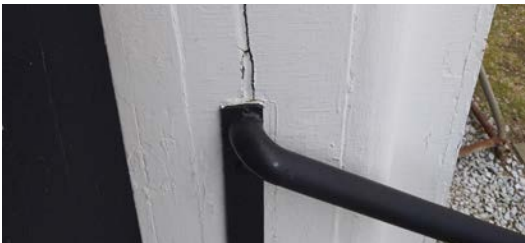
Image 2.08: Split wood jambs where the metal handrails are fastened should be monitored.

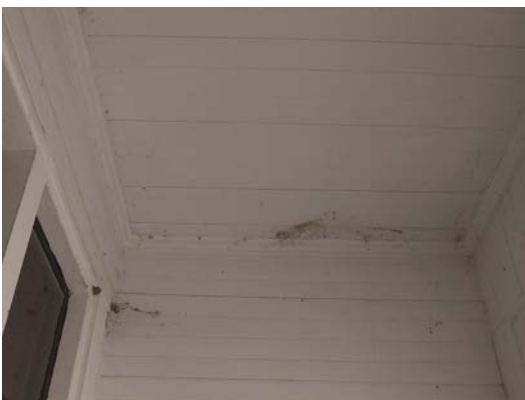
Image 2.09: Woodwork and paint in the entry alcove enjoy plenty of protection from the elements.

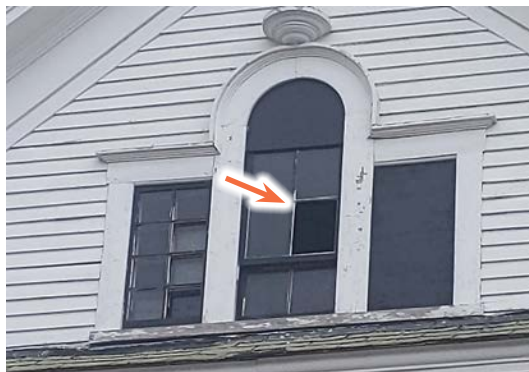
Image 3.02: The iconic Palladian window on the front facade requires complete restoration.

A Palladian window sits centered within the main facade's pediment, in what appears to be poor condition [Image 3.02]. Missing glazing and plywood panels cover the arched transom lite and the right-hand window. The sash appear to be wood, with faded paint and likely deteriorated rails.

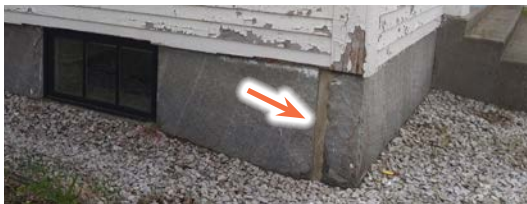
Image 4.02: Long, slender blocks of granite support the building's wood frame. Corners should be repointed.

The school greets visitors with a set of wide, concrete steps which lead into the recessed entry alcove [Image 4.01]. The steps are intact and show no signs of cracking or any real damage. The building sits upon a smooth grey granite most likely from the Chelmsford quarry. The blocks of granite are long and monolithic with very few head joints, save for at outside corners and intermittent windows [Image 4.02]. Some open mortar joints at the corners of windows are a risk of water infiltration, and should be easily addressed by repointing [Image 4.03].
